## Rapid News

Rapid news number: 20-08

Date: 30/07/2020

#### **SUBJECT: GCU II Combustion errors**

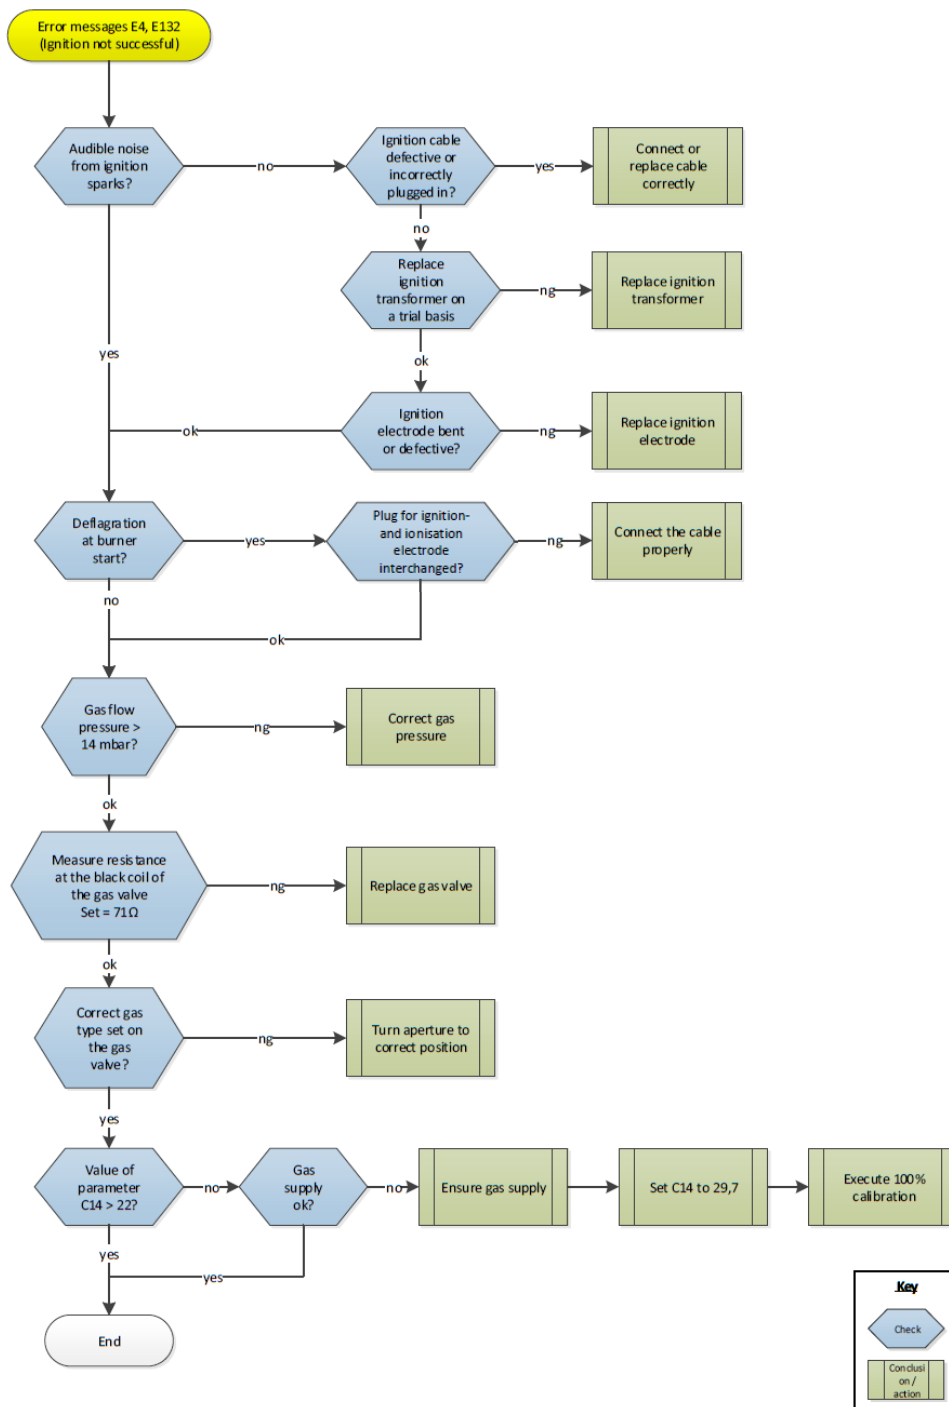
### E4 and E132

Error code	Fault description
<b>Temporary malfunction, unit attempts to restart</b>	E4	1x no flame formation at end of safety time (no gas, valves do not open, no ignition sparks);
	E10	Flame failure at end of the safety time (ionisation electrode defective or dirty);
	E55	Flame failure in control mode (influence of strong winds, no gas, power or signal loss at the safety gas control block) After restart, the device is operated for one hour with a limited modulation range;
	E61	Regulation deviation during ionisation process too high (1st error) (burner earthed incorrectly or faulty supply voltage combustion control, gas flow pressure too low, ionisation electrode bent or oxidised, ionisation track faulty, safety gas control block defective).
<b>Locking errors</b>	E132	2x no flame formation at end of safety time (no gas, valves do not open, no ignition sparks);
	E138	2x flame failure at end of safety time (ionisation electrode defective or dirty);

In the flowcharts presented next, the advised troubleshooting actions for each of the above mentioned errors can be found.

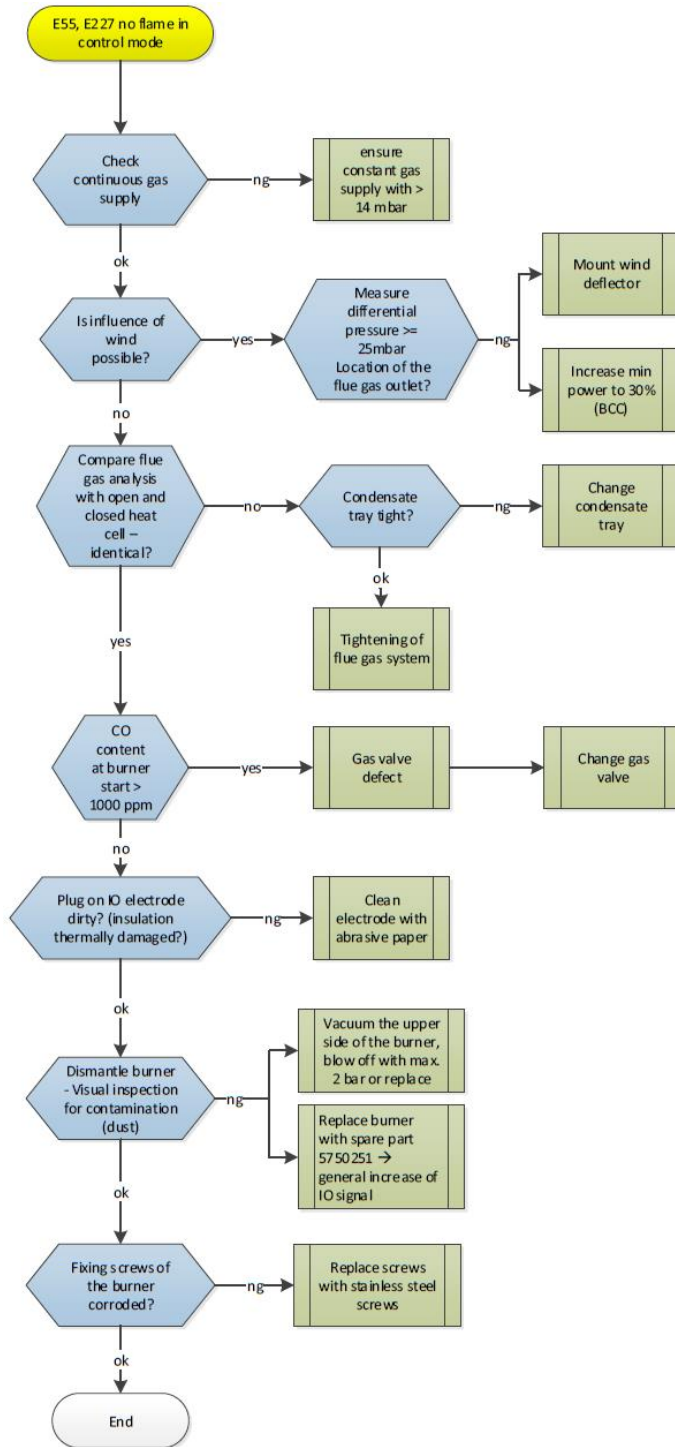
### E55 and E227

E189	Regulation deviation during ionisation process too high (from 2nd error) (burner earthed incorrectly or faulty supply voltage combustion control, gas flow pressure too low, ionisation electrode bent or oxidised, ionisation track faulty, safety gas control block defective);
	E226	Error found in the flame amplifier evaluation during the idle state check (electronic error, short circuit ionisation electrode or cable);
	E227	Combustion control internal error.
