Date: 27/07/2020
Author: Michal Galuska
SUBJECT: SAFETY ALERT RNQI20-16 + STOP SHIPMENT – Safety risk gas stop valve Split outdoor units

UPDATE 23/09/2020 – TO BE SHARED WITH AFFECTED CUSTOMERS

With this rapid news we want to inform you of a possible safety risk with the gas stop valves on some split outdoor units of the BML-H range, produced in the month June & July 2020.

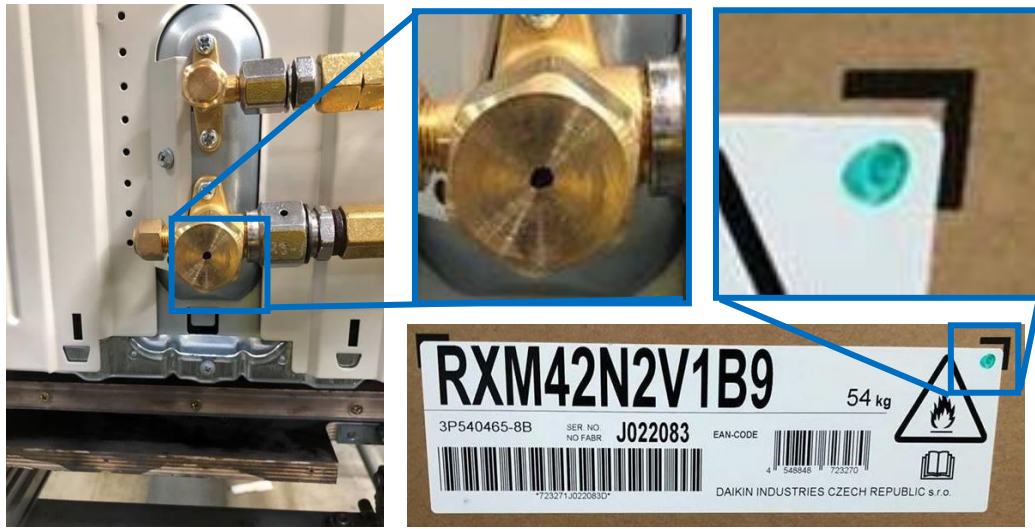
Units that were blocked in our stock or that were returned by our partners like you are being repaired in the factory. This means you might receive a unit which appears to be in-scope of the problem (based on the serial number ranges). Although the serial nr is within the scope, repaired units are perfectly safe, have a new valve and cap, and can be installed. Repaired units can be recognized by a marker dot on the packaging label and new valve cap – see following picture. Please ensure that such units are not returned to Daikin again, accidentally.

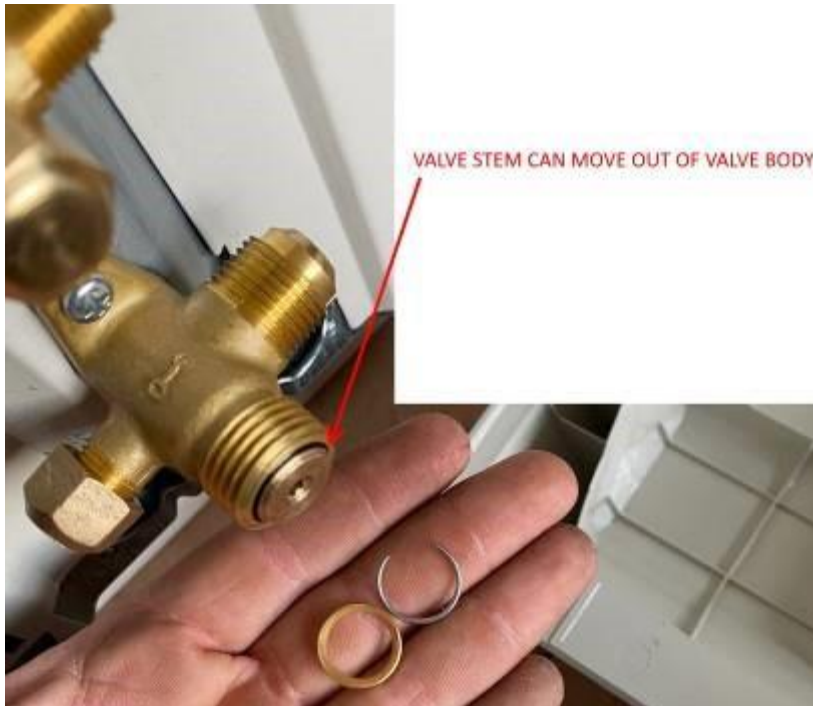
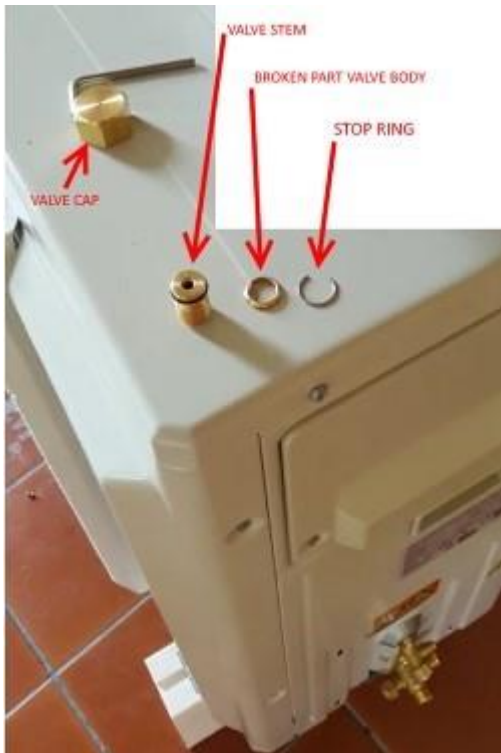
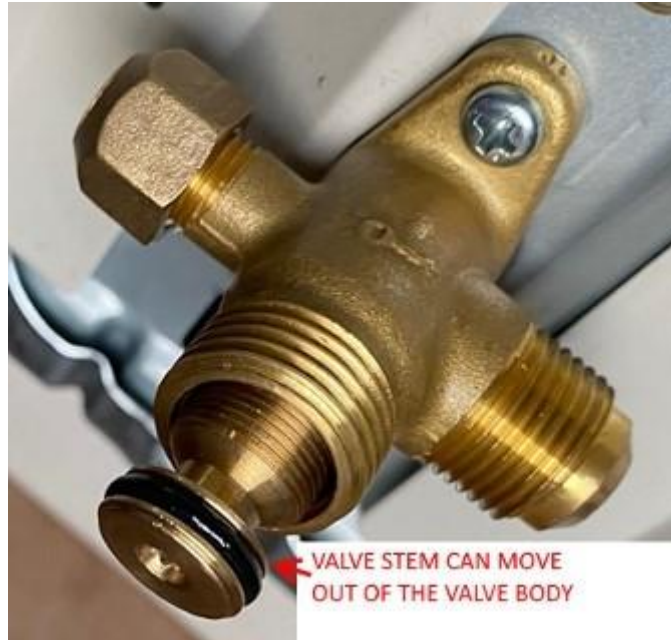
When opening the stop valve, there is a possibility that a part of the thread comes loose. If in this situation the installer continues to further open the valve, the stem of the valve could be ejected out of the valve with a high force and cause sudden release of refrigerant out of the unit. There is a risk for the person opening the valve to be hit by the valve stem or to suffer refrigerant burn marks.

Not yet installed units should not be commissioned, unless it can be assured that **maximum valve opening is limited to 10 complete rotations of 360°**. At 13 rotations the valve stem could come loose, normal full opening position is 11.5 rotations. As required during any service operation, please make sure to wear personal protective equipment such as safety glasses, safety gloves, safety shoes, etc... When putting back the original valve cap, only hand tighten it. [See Appendix!](#)

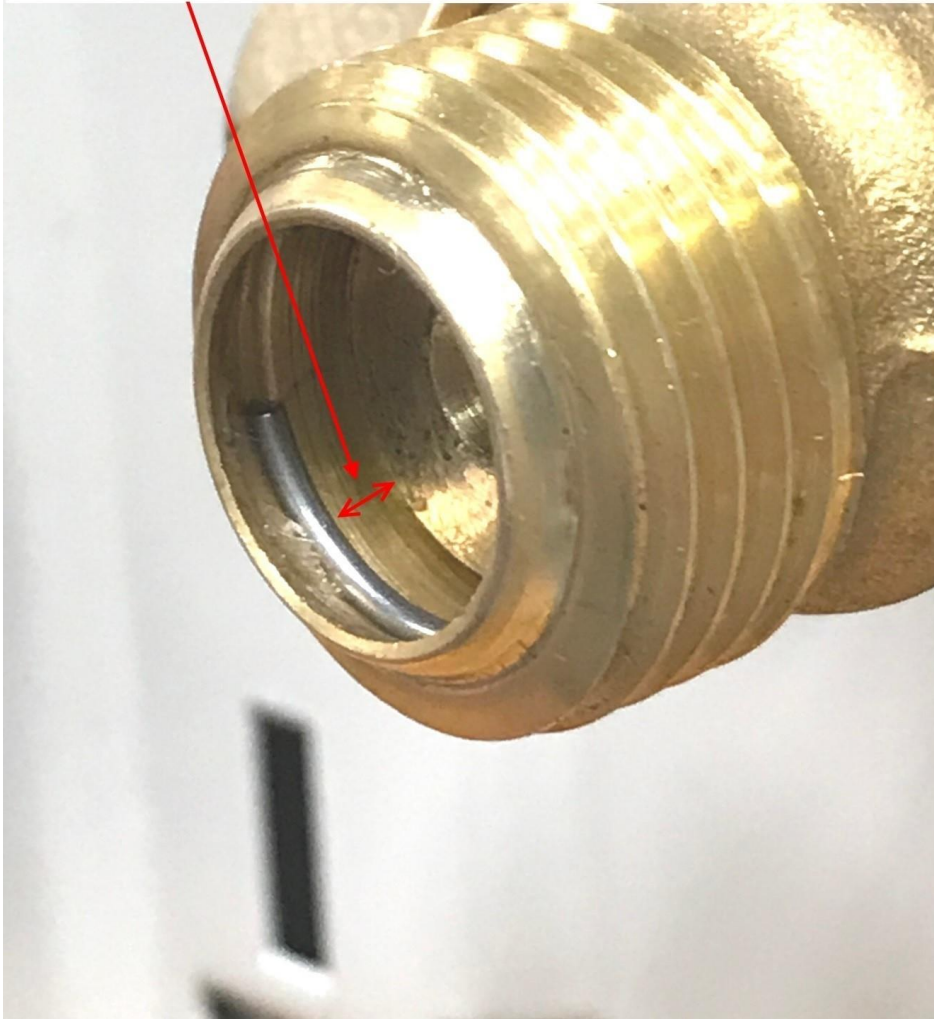
CAUTION !**MAXIMUM OPENING IS 10 ROTATIONS**

Turn clockwise to make sure valve is fully closed, then turn counter-clockwise for maximum 10 rotations !

The valve stem should not touch the stop ring !

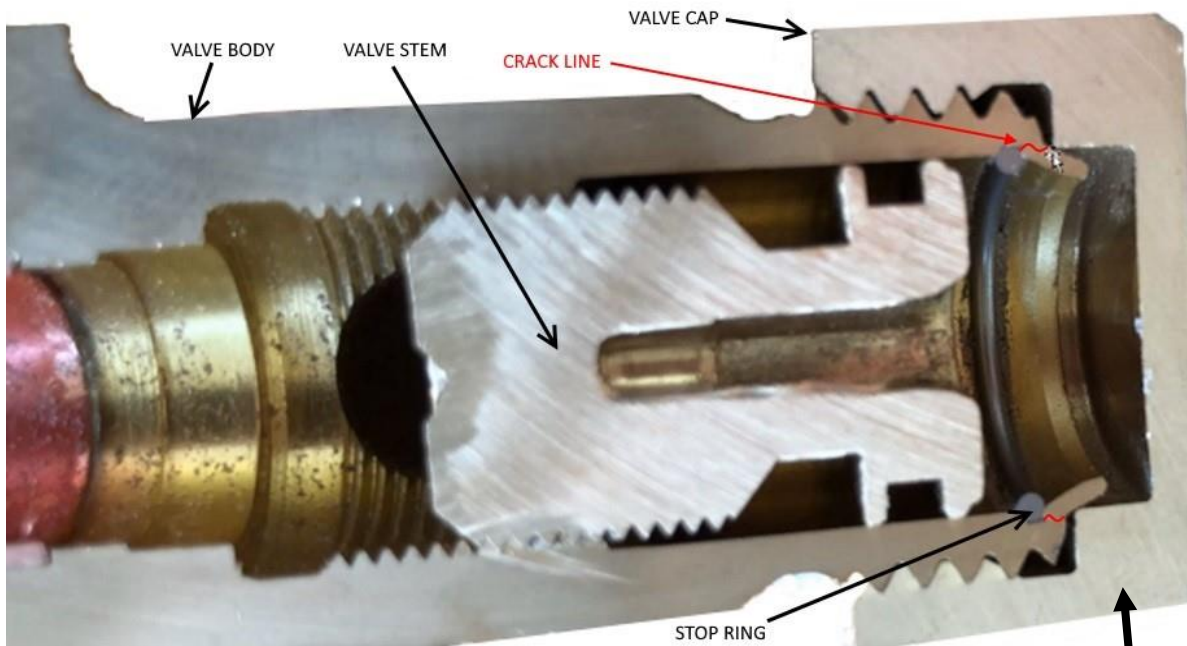
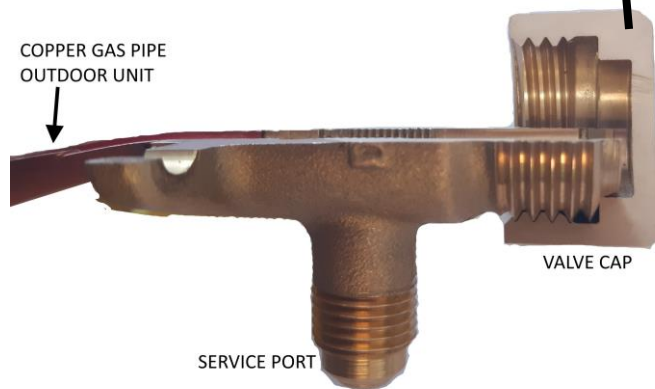
3 Cut-away view of the stop valve:

Hydraulic pressure test up to 220 bars have confirmed that the valve stem stays in place when opening the valve to a maximum of 10 rotations.

Too small inside diameter of the valve cap will cause a crack to the valve body when tightening the valve cap. When opening the valve stem, the top part of the valve body can fall off and release the stop ring. If the valve is then opened more than 13 rotations, the valve stem can be pushed out of the valve body with big force.
